**Flood Control Project Maintenance
Levee Inspections****LMA District Cover Sheet****Spring 2012 Levee Inspection Results****Reclamation District No. 2101 Blewett**

Levee Inspection Report By Mile - Spring 2012

Reclamation District No. 2101 Blewett

Waterway				Bank	Unit Miles	Inspection Start/End	Inspector
Unit No. 01 San Joaquin River				Left	3.20	05/02/2012 05/02/2012	Max Khashchuk

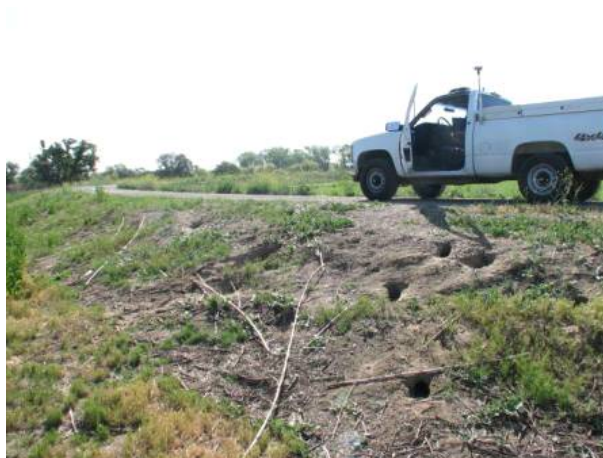
Levee Mile Report Line	5
Start Levee Mile	0.04
End Levee Mile	0.04
Location	Water Side
Category	Earthen Levee
Item	Animal Control

View of rodent holes on waterward slope, facing upstream.

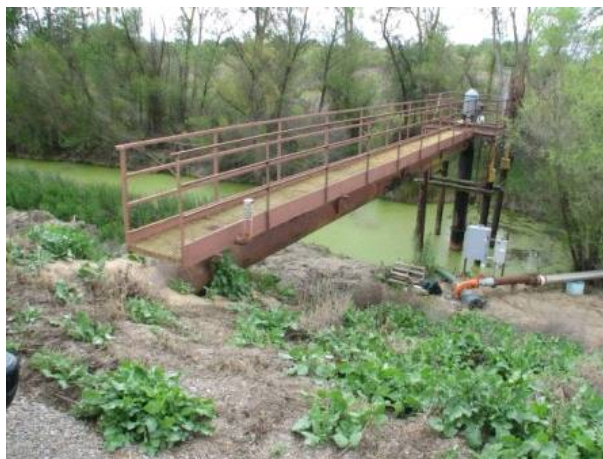
Levee Mile Report Line	8
Start Levee Mile	0.19
End Levee Mile	0.19
Location	Crown
Category	Earthen Levee
Item	Encroachments

Drainage discharge under levee crown.

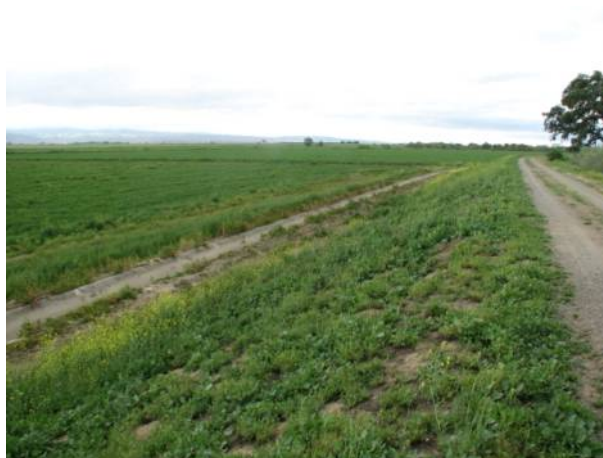
Levee Mile Report Line	12
Start Levee Mile	0.76
End Levee Mile	1.80
Location	Land Side
Category	Earthen Levee
Item	Encroachments

Concrete ditch near landside toe.

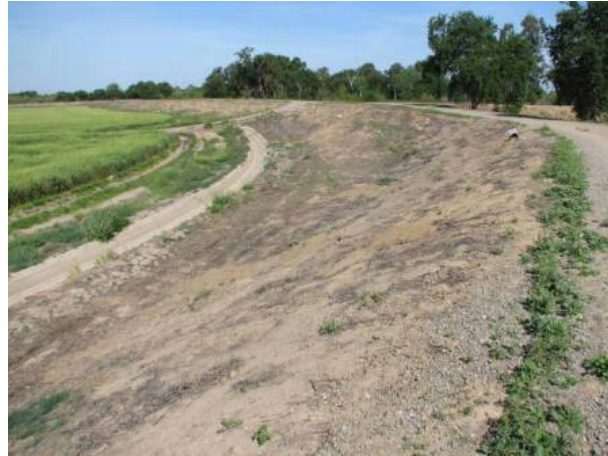
Levee Mile Report Line	14
Start Levee Mile	0.80
End Levee Mile	0.80
Location	Land Side
Category	Earthen Levee
Item	Animal Control

View of levee material removed by rodent activity on landside slope facing downstream. 05/02/2012

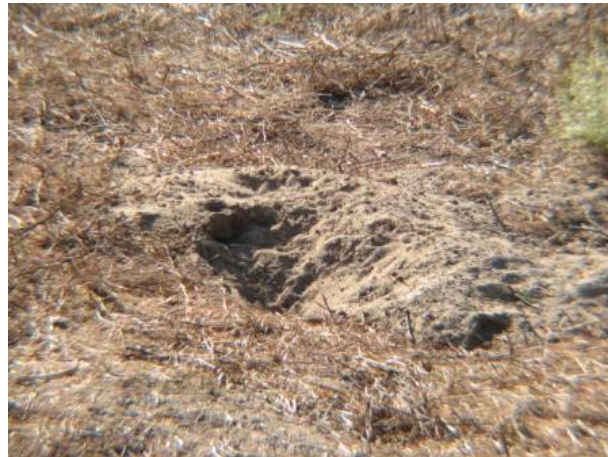
Levee Mile Report Line	16
Start Levee Mile	0.88
End Levee Mile	0.88
Location	Land Side
Category	Earthen Levee
Item	Animal Control

11/02/2011 Active rodent burrow.

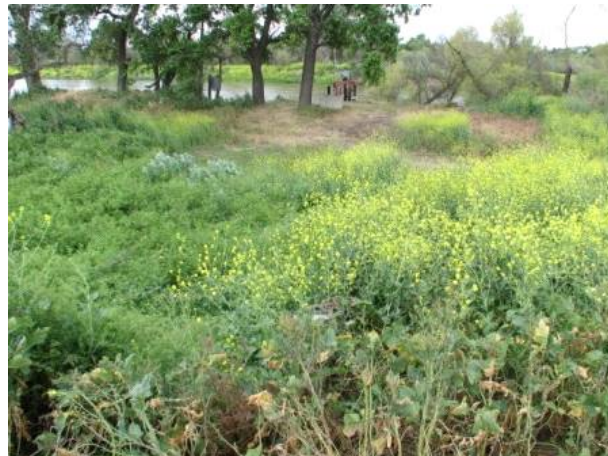
Levee Mile Report Line	21
Start Levee Mile	1.61
End Levee Mile	1.61
Location	Water Side
Category	Earthen Levee
Item	Encroachments

Photo of pump in background and CMP riser with valve in foreground.

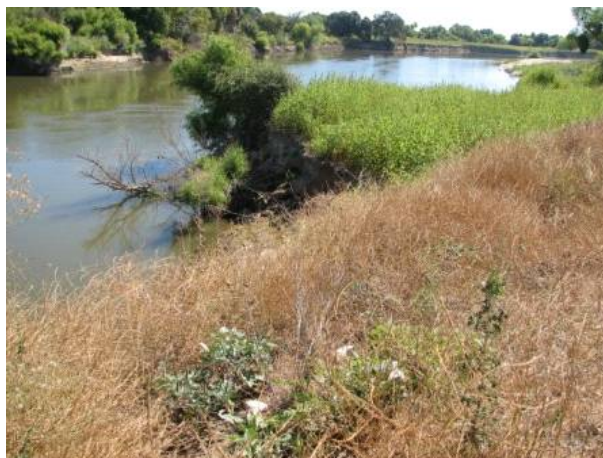
Levee Mile Report Line	24
Start Levee Mile	1.91
End Levee Mile	2.00
Location	Water Side
Category	Supplemental
Item	DWR Erosion Survey

Looking upstream from levee top. The tree at the water edge is the visible starting point of the erosion.

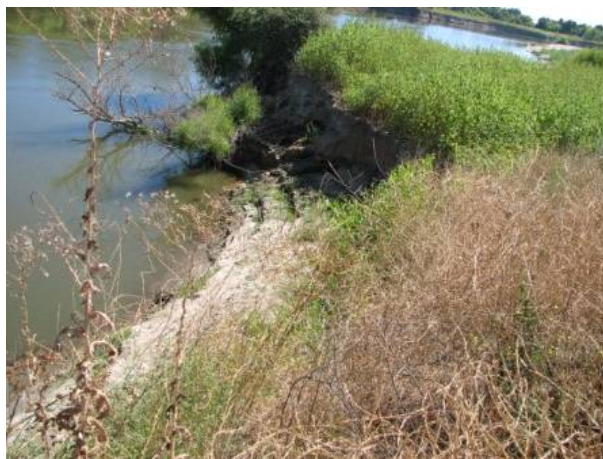
Levee Mile Report Line	24
Start Levee Mile	1.91
End Levee Mile	2.00
Location	Water Side
Category	Supplemental
Item	DWR Erosion Survey

A close look at the erosion. The viewing point is about half of the levee slope.

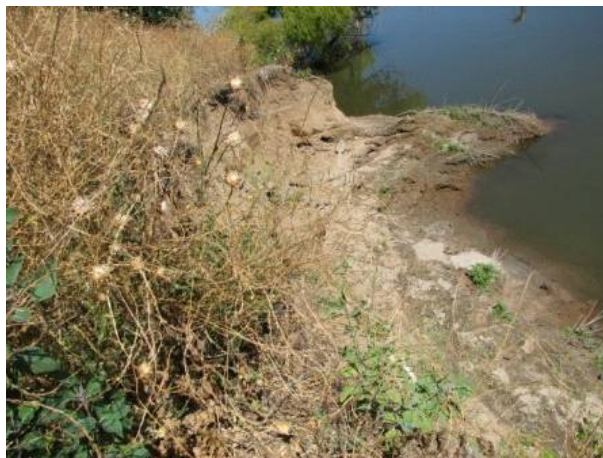
Levee Mile Report Line	24
Start Levee Mile	1.91
End Levee Mile	2.00
Location	Water Side
Category	Supplemental
Item	DWR Erosion Survey

Looking downstream at the scour site. The erosion has developed to about 1/3 of the levee slope. The levee toe has been washed away.

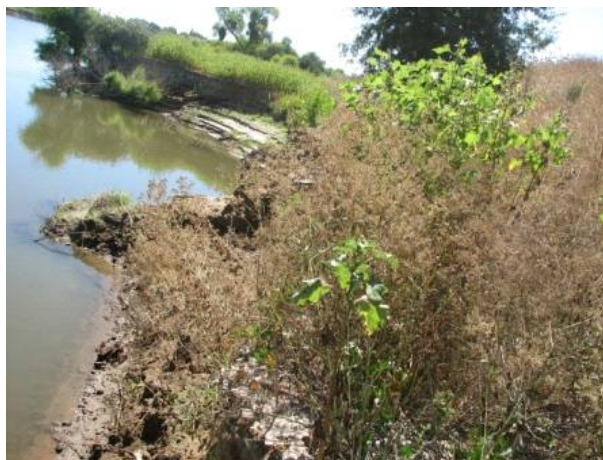
Levee Mile Report Line	24
Start Levee Mile	1.91
End Levee Mile	2.00
Location	Water Side
Category	Supplemental
Item	DWR Erosion Survey

Looking upstream at the scour site. The dense vegetation visible.

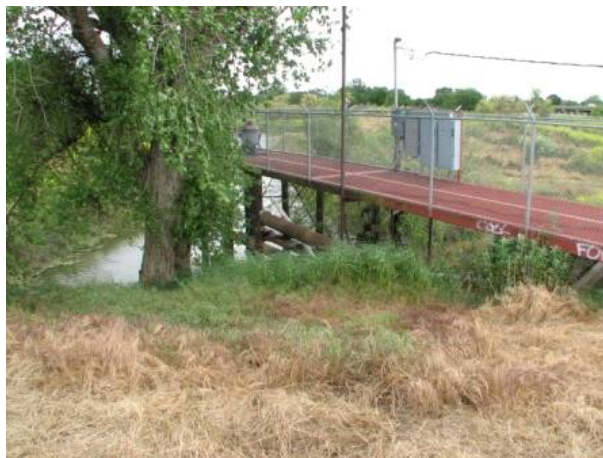
Levee Mile Report Line	27
Start Levee Mile	2.74
End Levee Mile	2.74
Location	Water Side
Category	Earthen Levee
Item	Encroachments

Irrigation intake near Maze Blvd.

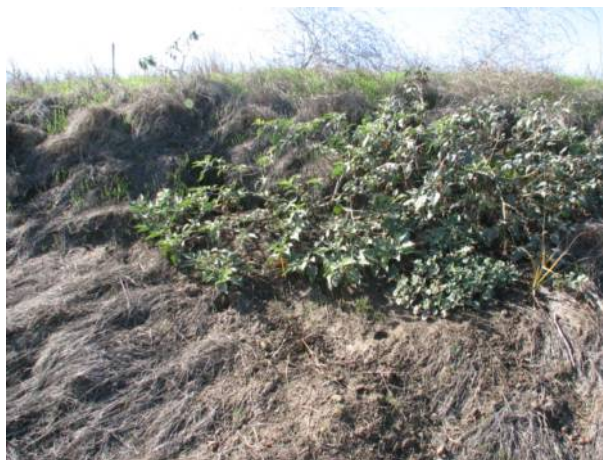
Levee Mile Report Line	28
Start Levee Mile	2.88
End Levee Mile	2.88
Location	Water Side
Category	Earthen Levee
Item	Animal Control

Rodent holes on levee slope hidden by vegetation.

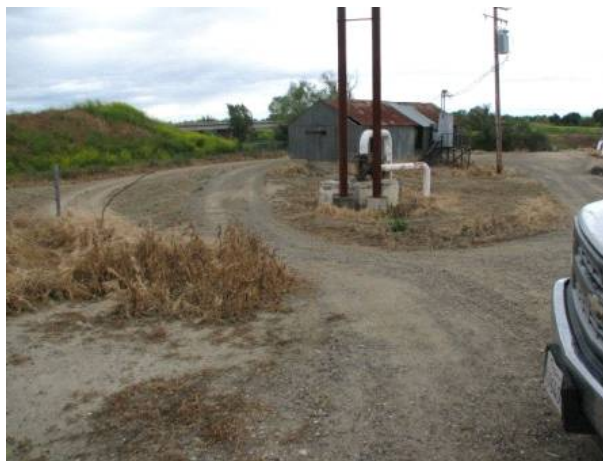
Levee Mile Report Line	29
Start Levee Mile	2.89
End Levee Mile	2.89
Location	Water Side
Category	Earthen Levee
Item	Encroachments

Risers on waterside berm and risers along road leading to levee indicate presence of pipe penetration.

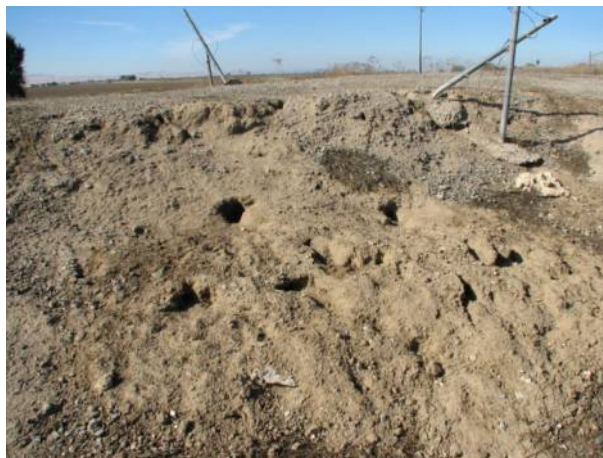
Levee Mile Report Line	30
Start Levee Mile	2.89
End Levee Mile	2.89
Location	Land Side
Category	Earthen Levee
Item	Animal Control

Rodent holes on levee slope.

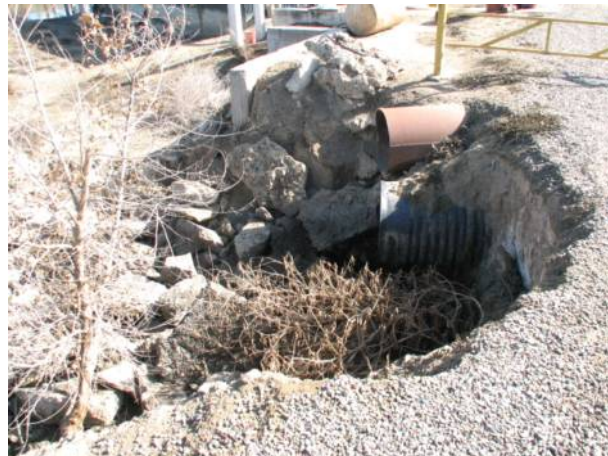
Levee Mile Report Line	31
Start Levee Mile	2.91
End Levee Mile	2.91
Location	Water Side
Category	Earthen Levee
Item	Erosion / Bank Caving

Levee slope is being eroded at this location. Repair needed to preserve access road.

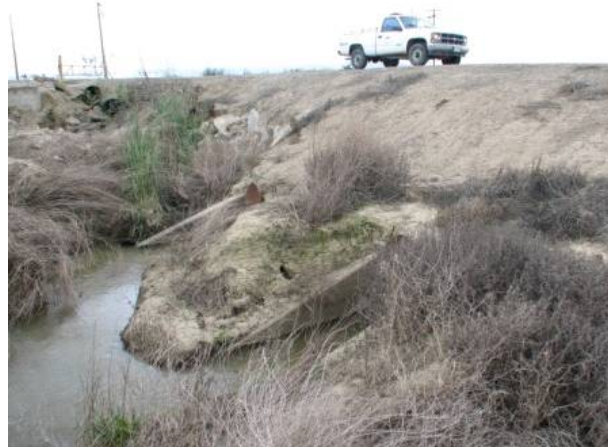
Levee Mile Report Line	32
Start Levee Mile	2.91
End Levee Mile	2.91
Location	Water Side
Category	Earthen Levee
Item	Encroachments

Drainage discharge to San Joaquin River.

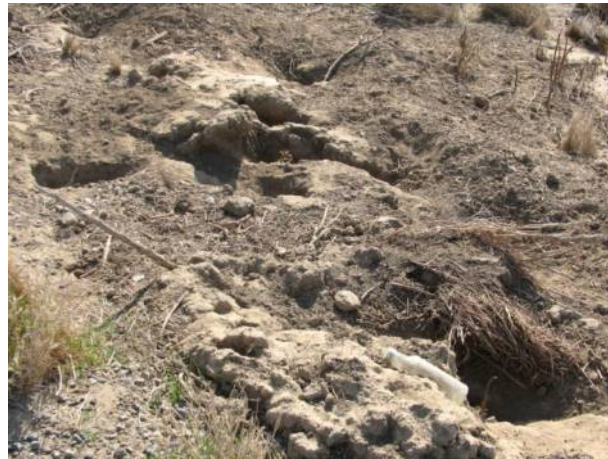
Levee Mile Report Line	33
Start Levee Mile	3.02
End Levee Mile	3.20
Location	Land Side
Category	Earthen Levee
Item	Animal Control

11/02/2011 Numerous burrows present, some already caving in, others are active.

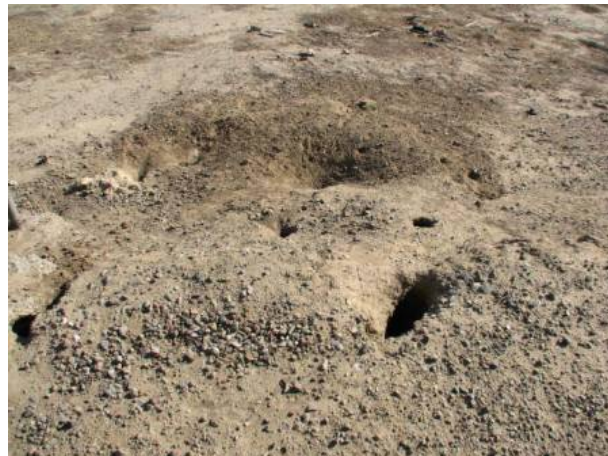
Levee Mile Report Line	33
Start Levee Mile	3.02
End Levee Mile	3.20
Location	Land Side
Category	Earthen Levee
Item	Animal Control

11/02/2011 Many active burrows present.

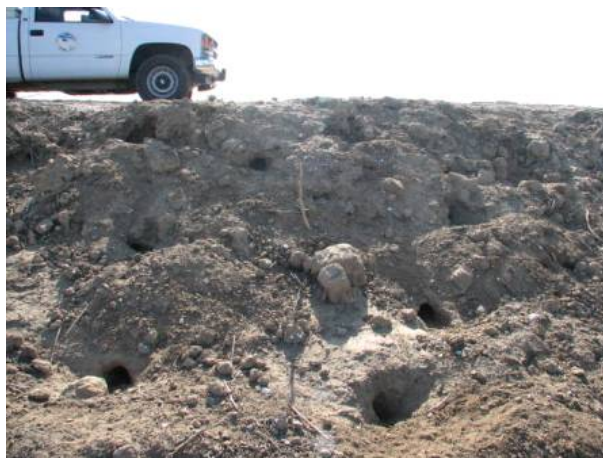
Levee Mile Report Line	33
Start Levee Mile	3.02
End Levee Mile	3.20
Location	Land Side
Category	Earthen Levee
Item	Animal Control

11/02/2011 Many burrows present throughout the levee slope.

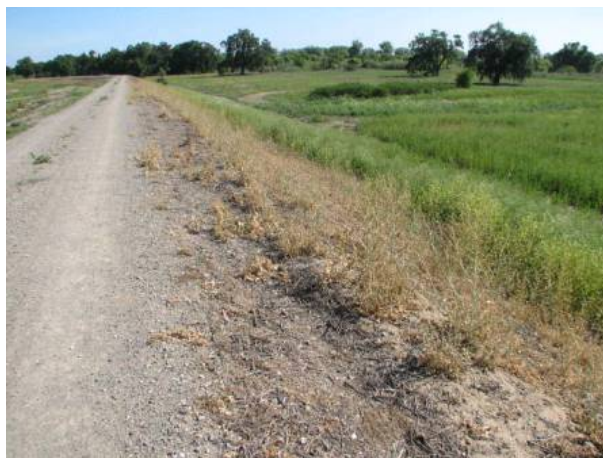
Levee Mile Report Line	1
Start Levee Mile	0.03
End Levee Mile	0.14
Location	Water Side
Category	Earthen Levee
Item	Vegetation

View of tall native grass on waterward slope, facing downstream. 05/02/2012

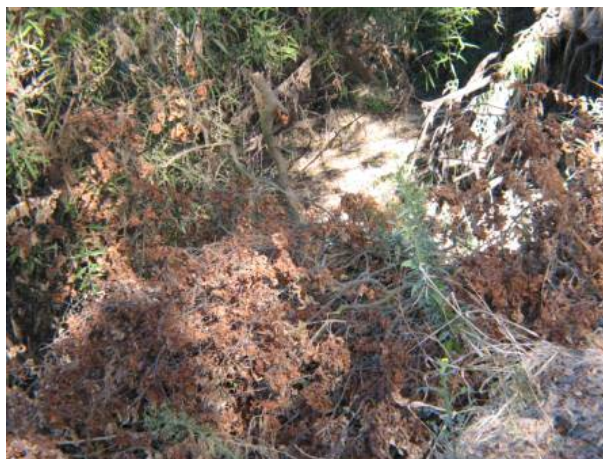
Levee Mile Report Line	2
Start Levee Mile	0.31
End Levee Mile	0.31
Location	Water Side
Category	Earthen Levee
Item	Erosion / Bank Caving

11/02/2011 Updated photo of the scouring occurring at the end of the spur levee.
